## INITIAL EXPENDABLE TURBOJET PROTOTYPE TESTING EXPIRIENCES

Nikola DAVIDOVIĆ<sup>1</sup>, Nenad Kolarević<sup>2</sup>, Miloš Stanković<sup>3</sup>, Marko Miloš<sup>4</sup>

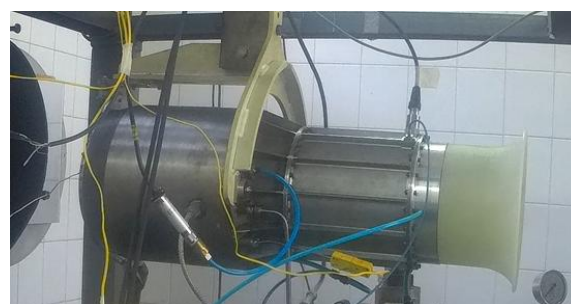
50% of the maximum rpm. In order to clarify the nature of the problem next test was done without nozzle. That test was successful with engine performances as expected. The position of the working line at the compressor map was in the expected range so the conclusion was that the problem was due to exhaust nozzle. Actually, the shape of the initial exhaust nozzle was dictated by some structural analysis results which shown that there are possible natural frequencies in the working range. After second analysis it was concluded that there is no force which could excite nozzle at desired frequency and that it will be almost impossible to satisfy required shape and pressure drop of the nozzle and to avoid such natural frequencies. The next tests were made without exhaust nozzle to verify mechanical behavior of the engine until the new designed nozzle was produced, as shown at the Fig. 3. The working lines without nozzle, with nozzle without central body and with final design nozzle are shown at the Fig. 4.

**Fig. 3.** TJE-200 at test without nozzle

The first engine test shown the compressor surge issues during the starting approximately around
