## INITIAL EXPENDABLE TURBOJET PROTOTYPE TESTING EXPIRIENCES

Nikola DAVIDOVIĆ<sup>1</sup>, Nenad Kolarević<sup>2</sup>, Miloš Stanković<sup>3</sup>, Marko Miloš<sup>4</sup>

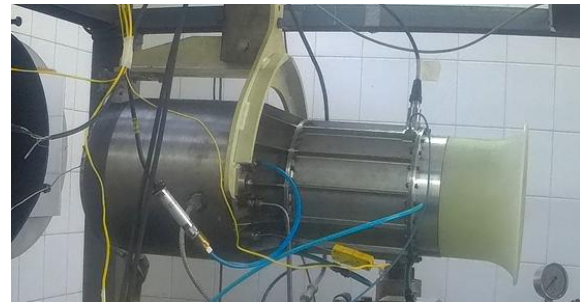
**Fig. 3.** TJE-200 at test without nozzle

50% of the maximum rpm. In order to clarify the nature of the problem next test was done without nozzle. That test was successful with engine performances as expected. The position of the working line at the compressor map was in the expected range so the conclusion was that the problem was due to exhaust nozzle. Actually, the shape of the initial exhaust nozzle was dictated by some structural analysis results which shown that there are possible natural frequencies in the working range. After second analysis it was concluded that there is no force which could excite nozzle at desired frequency and that it will be almost impossible to satisfy required shape and pressure drop of the nozzle and to avoid such natural frequencies. The next tests were made without exhaust nozzle to verify mechanical behavior of the engine until the new designed nozzle was produced, as shown at the Fig. 3. The working lines without nozzle, with nozzle without central body and with final design nozzle are shown at the Fig. 4.

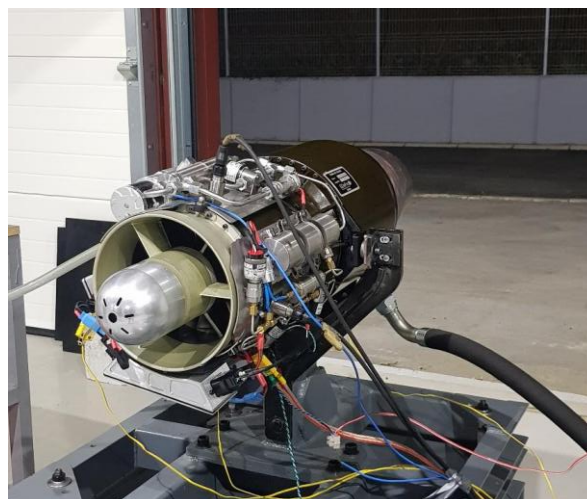
Fig. 7. Final version of the turbojet engine TJE-200 with subsystems at the test stand
