## RESIDUAL STRESS-INDUCED DAMAGE IN BRAKE DRUMS

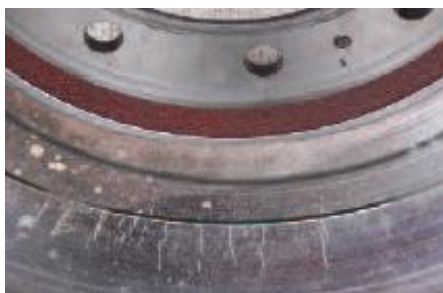
**Fig. 1.** Heat-checking.

Heat-checking or thermal cracks appear as a series of narrow, short, and shallow cracks on the braking surface of the drum (Fig. 1) [6]. They occur under normal operating conditions due to alternating heating and cooling of the friction surface of the drum and are considered a typical characteristic of drum brakes. These cracks do not affect braking torque or other functional parameters. Because of their shallow depth, thermal cracks usually wear away during operation as the friction surface of the drum undergoes normal wear, but they reappear again as a result of the braking process. However, there is a possibility that over time heat-checking may develop into more serious cracks, which would require drum replacement. Therefore, during routine inspections of a vehicle's braking system, special attention should also be paid to the condition of thermal cracks on the drum.

As shown in Fig. 1, thermal cracks appear on the friction surface of the drum that is closer to the

mounting plate. On the opposite side, where the drum is cooled more evenly, such cracks are almost absent. All thermal cracks are oriented in the axial direction of the drum. This indicates that they occur as a result of tangential tensile stresses on the friction surface that arise during the cooling of the drum. How can the formation of thermal cracks be explained?

During braking, intensive local heating of the contact surfaces between the drum and the brake linings occurs. As the temperature rises, the diameter of the material layers near the friction surface of the drum increases. This expansion is constrained by the adjacent layers of material that are less heated. Consequently, the outer layers of the drum wall are subjected to tensile stresses, while the inner layers are subjected to compressive stresses. If the total stresses in the outer layers exceed the yield strength, plastic deformation and an increase in drum diameter will occur. When the friction surface cools, its diameter decreases. This contraction is resisted by the plastically deformed outer shell. As a final result of the non-uniform heating and cooling of the drum wall, compressive residual stresses are formed in the plastically deformed outer layers of the drum wall, while tensile tangential residual stresses occur in the interior. It can be assumed that the maximum values of tensile tangential stresses appear in the surface layers of the friction surface. Their intensity is evidently greater than the tensile strength of the drum material, which leads to crack formation.

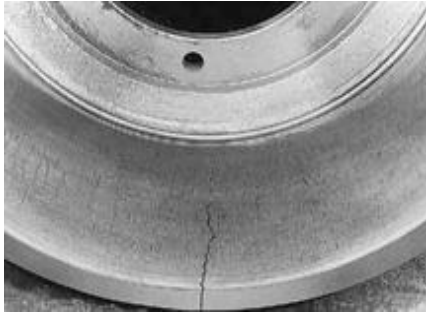
**Fig. 2.** Cracked drum.

The most common cause of cracking in brake drums is residual thermal stress, which develops due to uneven heating and cooling during operation. In some cases, the intensity of residual stresses alone may be sufficient to initiate a crack. More frequently, residual stresses are superimposed with service stresses caused by external loads. If the total stress exceeds the tensile strength of the material, a crack will occur, its size being proportional to the stress intensity. Even small cracks in the drum wall can, over time and under dynamic loading, lead to complete drum failure. This raises the question of establishing a criterion for when the brake drum should be replaced, depending on the crack dimensions.

A cracked drum (Fig. 2.) [6] can be detected through visual inspection. The crack typically runs in the axial direction and extends through the entire

wall of the drum. It always appears perpendicular to the sliding direction of the brake shoe.

The reduction of drum wall thickness, either due to wear or due to machining aimed at eliminating detected defects, additionally decreases the static strength of the drum and increases the likelihood of crack formation. In the drum section where a crack has developed, elastic deformations are more pronounced, which leads to an uneven pressure distribution along the arc length of the friction lining and to a significant reduction of the braking torque. As a consequence, brake vibrations become strongly pronounced. Depending on the cause of origin, cracks in the drum may occur during the entire service life of the component. A cracked drum must be replaced, which means that this type of failure leads to the complete failure of the brake drum.

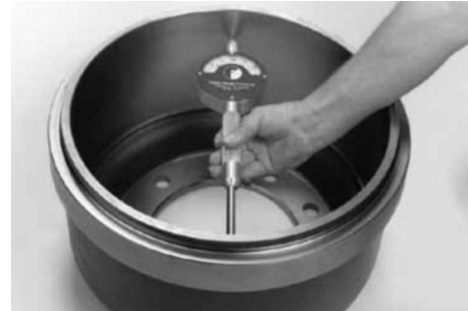
**Fig. 3.** Measurement of drum deformations.

Variation in drum diameter at different points along the braking surface, as well as uneven wear of the drum and brake linings, are indicators of an

out-of-round drum. The magnitude of drum deformation is determined by measuring the drum diameter (Fig. 3) [6] at different points on the braking surface.

On each brake drum, the manufacturer marks the values of the internal diameter of a new drum and the maximum permissible diameter, beyond which mandatory replacement is required. If the maximum measured diameter of the drum's friction surface is smaller than the maximum permissible diameter, the drum can be machined in order to restore concentricity. Otherwise, the drum must be replaced. This means that deformed drums belong to the group of conditionally repairable components.

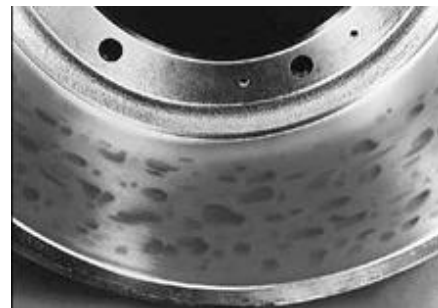
**Fig. 4.** Martensite spots.

Martensite spots appear as extremely hard, slightly raised dark patches on the friction surface of the brake drum (Fig. 4) [6]. The presence of these dark spots indicates that the drum has been exposed to operating temperature regimes that caused structural changes in the drum material. During rapid cooling of a heated drum made of gray cast iron, the austenitic structure of the material, with a face-centered cubic lattice, transforms into a martensitic structure with a body-centered cubic lattice. The structural transformation of austenite into martensite results in a relative increase in the material volume, which leads to the formation of raised dark spots on the drum's friction surface.

Due to structural changes in the material, compressive residual stresses occur in the martensitic zones, leading to an increase in material hardness. The color change of the drum material with a martensitic structure can be explained by the presence of graphite in the material structure. Namely, during rapid cooling of gray cast iron, carbon atoms do not have time to diffuse out of the austenite crystals, but remain in the material in the form of graphite needles or flakes.

The presence of raised, hard, dark spots on the friction surface of the brake drum reduces the effective contact area between the drum and the brake linings. This in turn leads to a decrease in braking torque, severe local heating, uneven wear of the brake linings, brake pedal pulsation, and the occurrence of vibrations and excessive noise during braking. In addition to structural residual stresses, intense local heating and non-uniform cooling of the friction surface give rise to thermal residual stresses. The complex stress state resulting

from the combined effect of residual and service stresses causes deformation of the brake drum and the initiation of fatigue cracks on the friction surface. Failure to detect martensitic spots in a timely manner and eliminate the cause of brake drum overheating inevitably leads to mandatory drum replacement.
