QUANTITATIVE DETERMINATION OF GLASS FIBER CONTENT IN FIBER-REINFORCED COMPOSITE MATERIALS

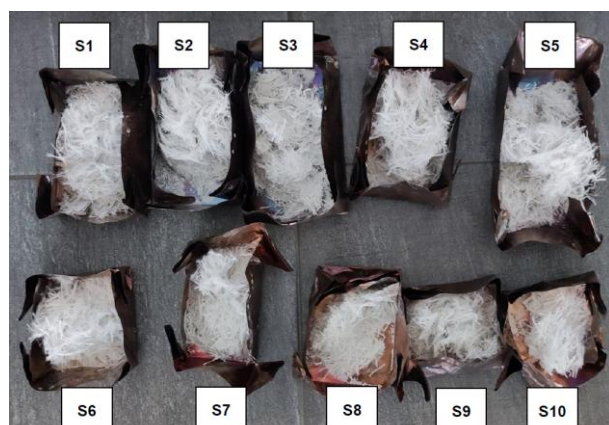
Fig. 4. Specimens after exposing to high temperature, cleaned of base material and prepared for measurement.

The mass of each sample before and after the test was precisely measured with an analytical balance (Figure 3b). The furnace with high-temperature combustion at 600 °C is used to remove the polymer matrix in the specimens (Fig. 3c). The specimens after burning contained a certain amount of powdered base material, so they were separated from the glass fibres (Figure 4).

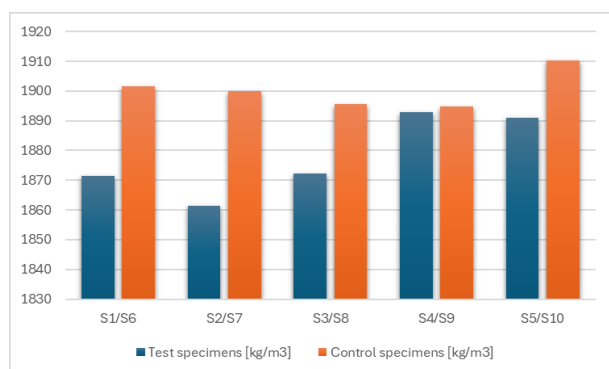
Fig. 5. Density of specimens

Figure 5 shows the density of the specimens, while Figure 6 shows the fiber glass content in the composite material.

The results revealed a slightly higher average fibre mass fraction in the defect-prone zone compared to control areas, accompanied by a marginal decrease in density. This indicates potential microstructural irregularities such as voids, resin-rich areas, or incomplete fibre impregnation, which could influence local stiffness, stress distribution, and crack initiation mechanisms. These findings highlight the importance of combining compositional analysis with volumetric quality control to ensure consistent manufacturing quality and to improve the structural reliability of composite components in demanding operational environments.

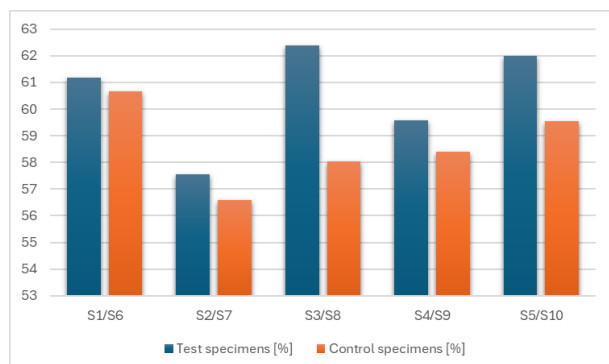
Fig. 6. Fiber Glass Content in the Composite Material
